U.S. Route 491 closed due to road damage from heavy rain

NASCHITTI, N.M.-U.S. Route 491 is closed to traffic both directions between Sheep Springs and Naschitti, near milepost 44, after heavy rains collapsed a portion of the roadway on night of July 5, 2013.

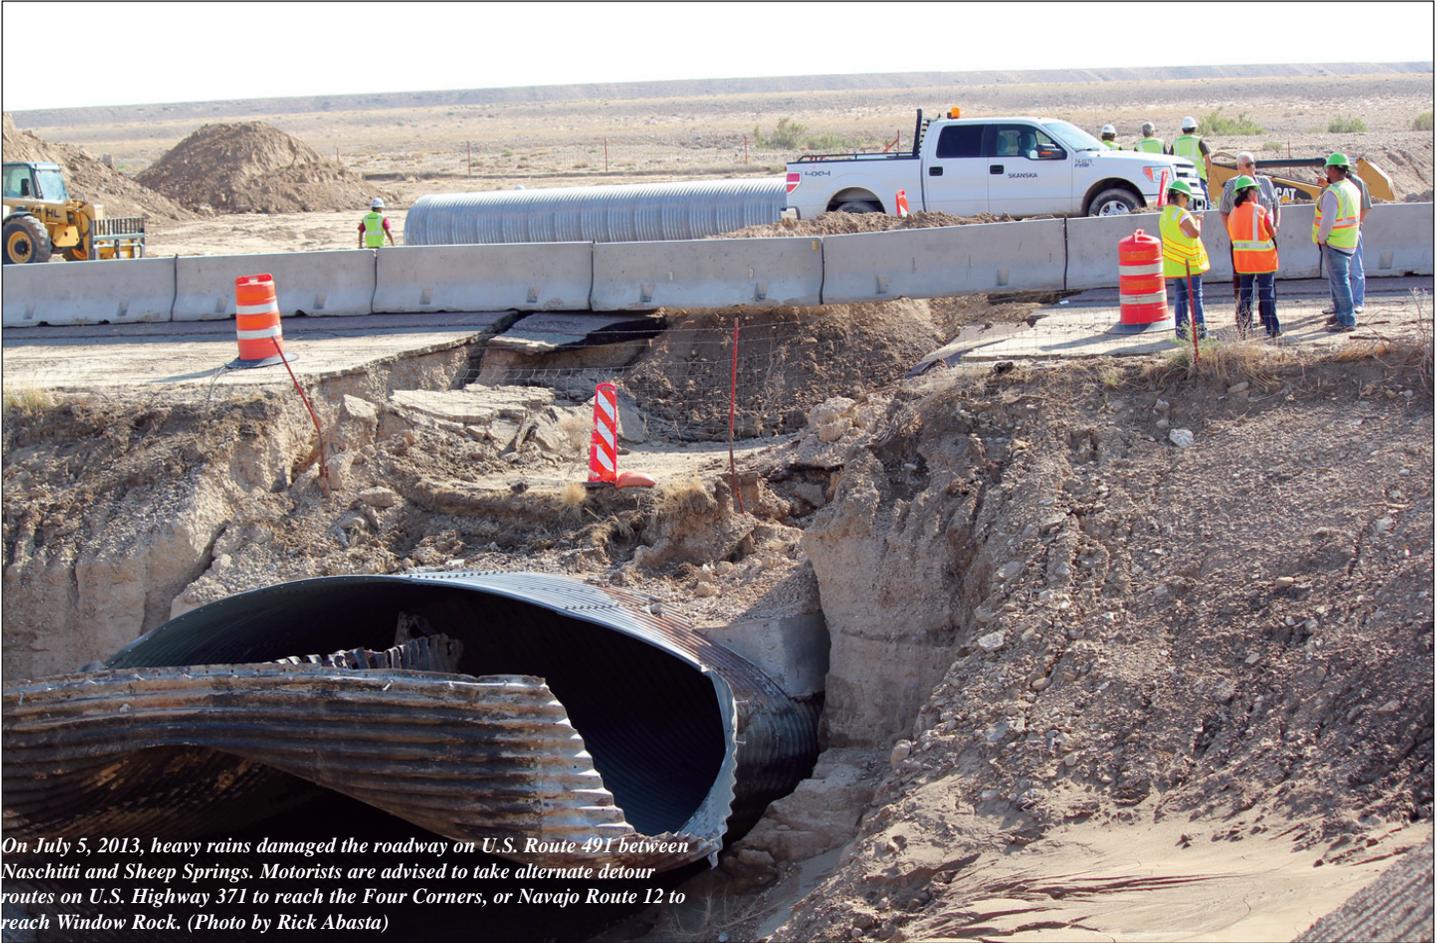
On July 5, 2013, heavy rains damaged the roadway on U.S. Route 491 between Naschitti and Sheep Springs. Motorists are advised to take alternate detour routes on U.S. Highway 371 to reach the Four Corners, or Navajo Route 12 to reach Window Rock. (Photo by Rick Abasta)

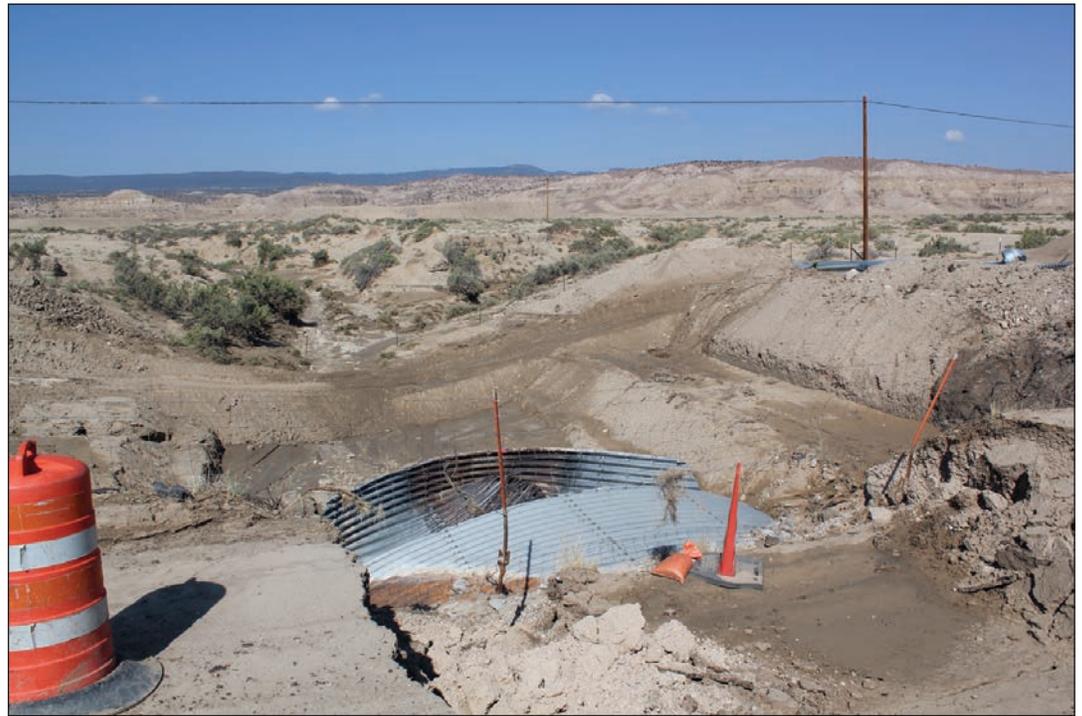
Herrera said three channels of water undermined a 24-foot-by-15-foot rise culvert. The rushing water bent the western side of the culvert up and caused the roadway to drop approximately 2.5-feet.

Three channels of water traveling from the Chuska Mountains undermined a culvert and caused a portion of U.S. Route 491 to collapse. NDOT crews are working on a detour route. (Photo by Rick Abasta)

route in place for emergency vehicles and detour route for essential traffic could be completed as early as July 10. Crewmembers are currently installing pipe and grading the area.

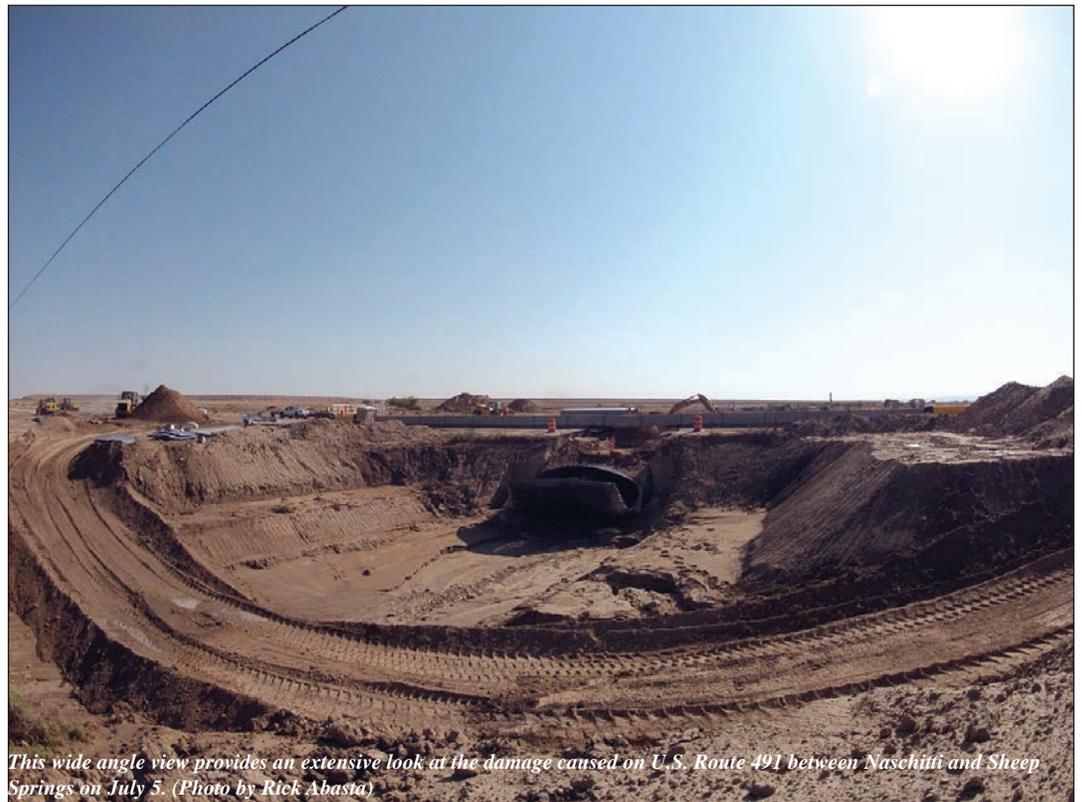
This wide angle view provides an extensive look at the damage caused on U.S. Route 491 between Naschitti and Sheep Springs on July 5. (Photo by Rick Abasta)
